**Flood Control Project Maintenance
Levee Inspections**

Maintenance Issue Types Only, Levee Inspection Report By Mile - Fall 2016

Reclamation District No. 2094 Wathal

Waterway	Bank	Unit Miles	Inspection Start/End	Inspector
Unit No. 01 San Joaquin River	Right	2.78	11/02/2016 11/02/2016	Maksim Khashchuk

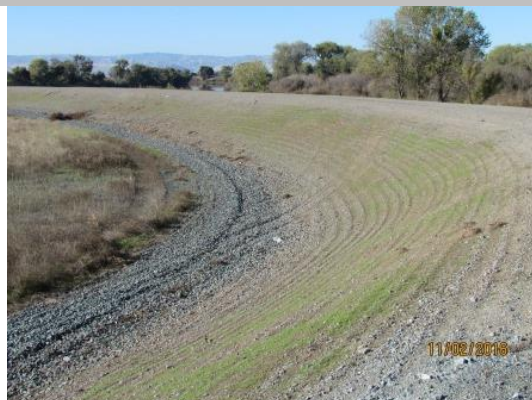
Photo 1 of 1 : FA_2016_RD2094_320_7_20161104_00014.jpg

LM Start	0.08	Rating **	A	Issue No.	7
LM End	1.39	Issue Type +	Ma	Location *	LS
Category	Earthen Levee			GPS Latitude/Longitude	
				Start	End
Item	Vegetation			37.771683 °	37.759492 °
				-121.299827 °	-121.299411 °
DWR ID	DWR_RD2094_01_f_2016_7				
Comment Code					
V1 : Control annual grass and weeds on the levee slopes and easements.					
Inspector Comment					
LMA has excellent vegetation control program.

View of the vegetation on the landside levee slope.

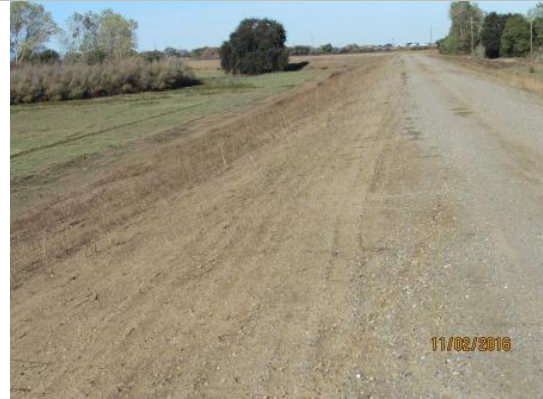
Photo 1 of 1 : FA_2016_RD2094_321_1_20161104_00001.jpg

LM Start	0.02	Rating **	A	Issue No.	1
LM End	0.43	Issue Type +	Ma	Location *	WS
Category	Earthen Levee			GPS Latitude/Longitude	
				Start	End
Item	Vegetation			37.759323 °	37.760606 °
				-121.299904 °	-121.306989 °
DWR ID	DWR_RD2094_02_f _ 2016_1				
Comment Code					
V1 : Control annual grass and weeds on the levee slopes and easements.					
Inspector Comment					
LMA has good vegetation control program.

View of the vegetation on the waterside levee slope.
